Range Restaurant

258 Great Alpine Road
Myrtleford 3737 Victoria

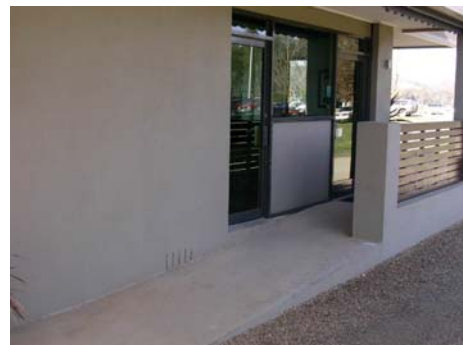
Picture 1: Entry

Path of travel to the restaurant entry is to cross a loose graveled driveway and parking areas. If parked at the front of the restaurant follow the line of the building approximately 10m to the left to the corner of the building where the entry is signed and then travel a further 10m to the ramped entry. If parking adjacent to entry cross the driveway for approximately 10m to reach the ramped entry. The concrete ramp has no rails until the top, is 990mm wide, approximately 8m long and is a gradient of 6.4%. The concrete ramp then levels out providing circulation space of approx 1000 x 1500mm immediately in front of reception door. A barrier exists along the edge of the landing. The door leading to the motel reception – which then leads to the restaurant – offers 980mm clearance and push door handle at 870 – 1100mm in height. The door is of medium weight with a self door closure.

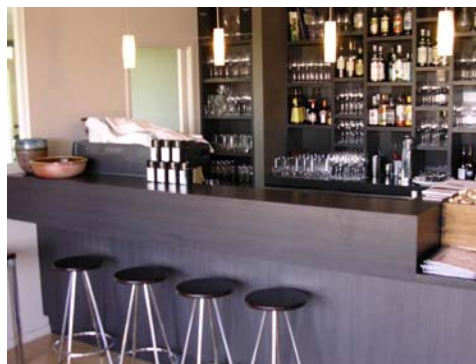
Picture 3: Bar

The main bar height is 1060mm with underside clearance to 880mm. A lower, smaller portion is 910mm high with again 880mm underside clearance. Signage is limited but lighting is ample.

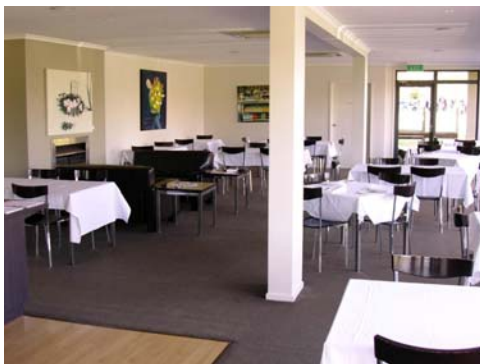
Picture 4: Dining area

The dining area is large (at least 15m x 8m) with the option of inside or outside seating. There is ample circulation space around tables with the room configured with several small tables (four legged, 900 x 900mm) and several large tables (four legged, 900 x 1500mm). The double sliding doorway to the outside decking has minimal threshold and at least 1000mm clearance. The outdoor decking offers ample circulation space.
